HISTORIC RESOURCE STUDY

BANNACK STATE PARK

est.
Historical Research Associates
Missoula, Montana

July 1982

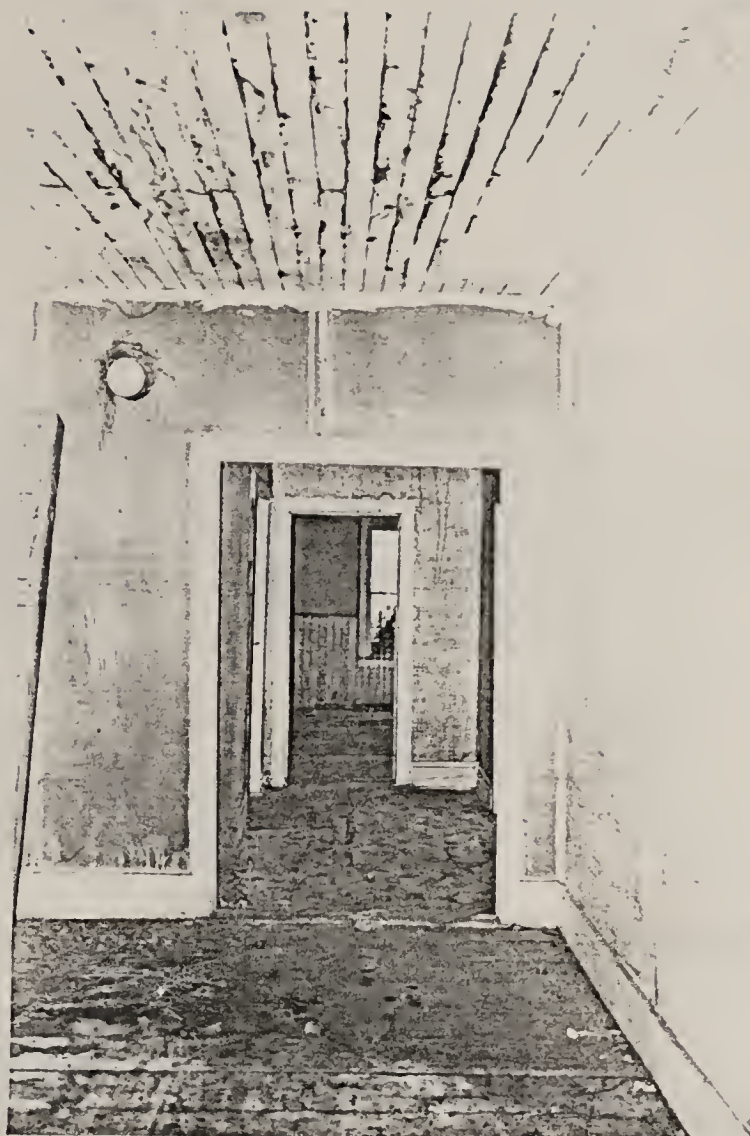
Figure 3-82. Looking toward
the rear of the house from
the front room.

[Water stains from roof leaks]

[Major ceiling damage in
the front room]

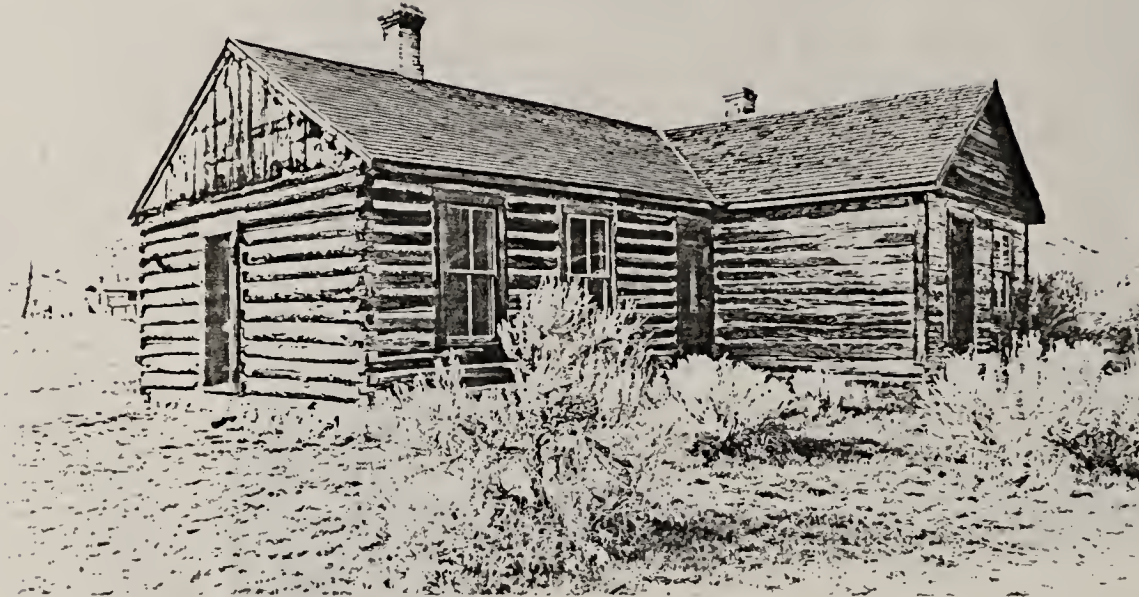
Figure 3-84. Looking northwest at residence.

The house is in good condition, with some new logs on the bottom west wall and also on the north section of the "L." There is some heaving of the floors. The south wall and gable end appear to have burned at one time.

The residence was acquired through donation to the State of Montana in 1954. Stabilization work performed is as follows: 1969--new cedar shingle roof; 1972--repair of rock foundation and new concrete foundation poured under west, north, and part of east walls; rotten logs replaced as necessary in west and north walls; chimneys repaired; windows and doors repaired.

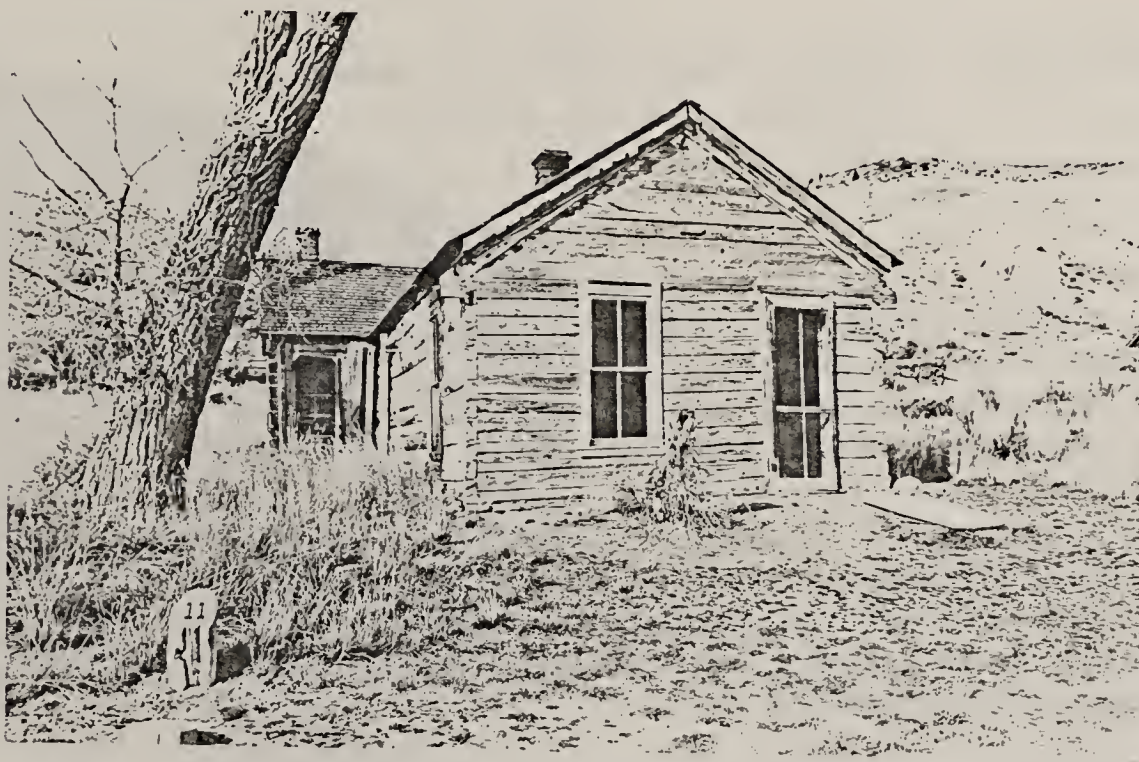
Figure 3-85. Looking north at residence.

Doors are wood panel. Two brick corbelled chimneys penetrate the cedar shingle roof. The interior of the residence has vertical board walls. The building rests on a stone and concrete foundation and is in fair to good condition.

The property was acquired in 1971 by Fish, Wildlife and Parks, and has been partially restored and stabilized as follows: 1972-73--reroofed with cedar shingles; repaired doors and windows; stabilized walls and roof structure; removed railroad ties on east wall and replaced with hand-hewn logs; poured concrete foundation where necessary.

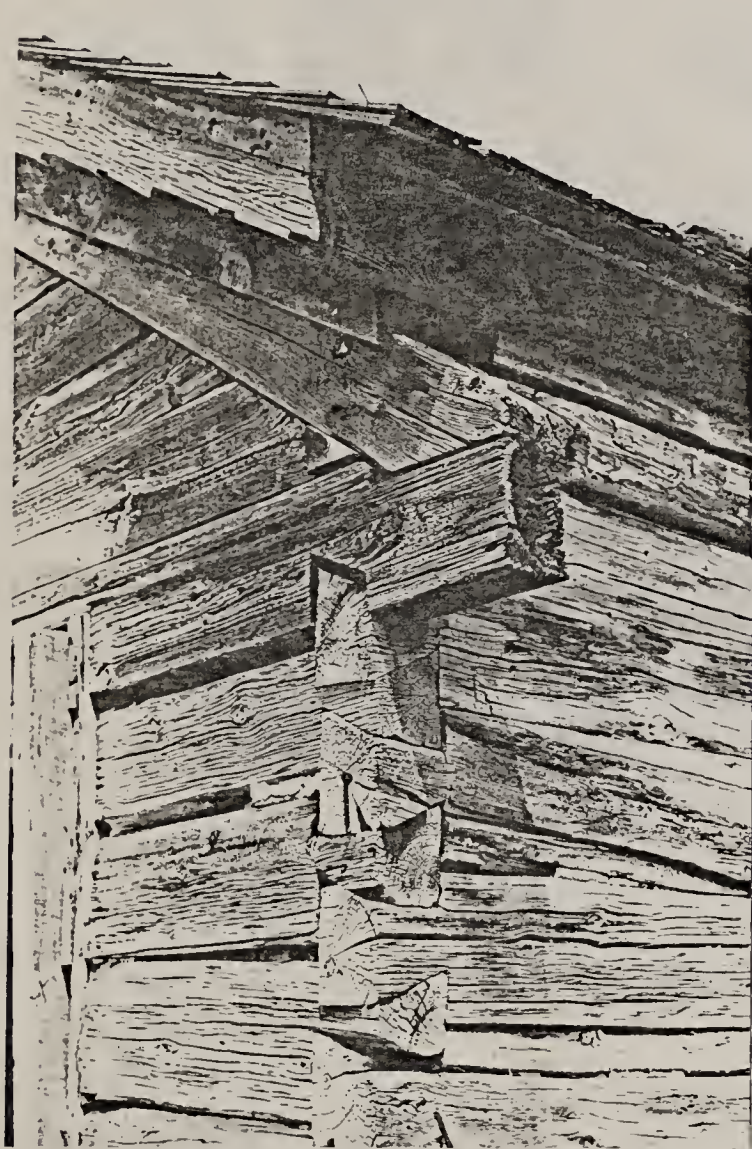
A modified, projecting raking cornice has been added atop the original raking cornice. The new raking cornice is at a slightly lower pitch than the original. Taking the new, lower pitch together with the addition of logs and board infill on the sides, you can see that the modification was made to add height or volume to the original work.

[Added logs and infill]

[New raking cornice]

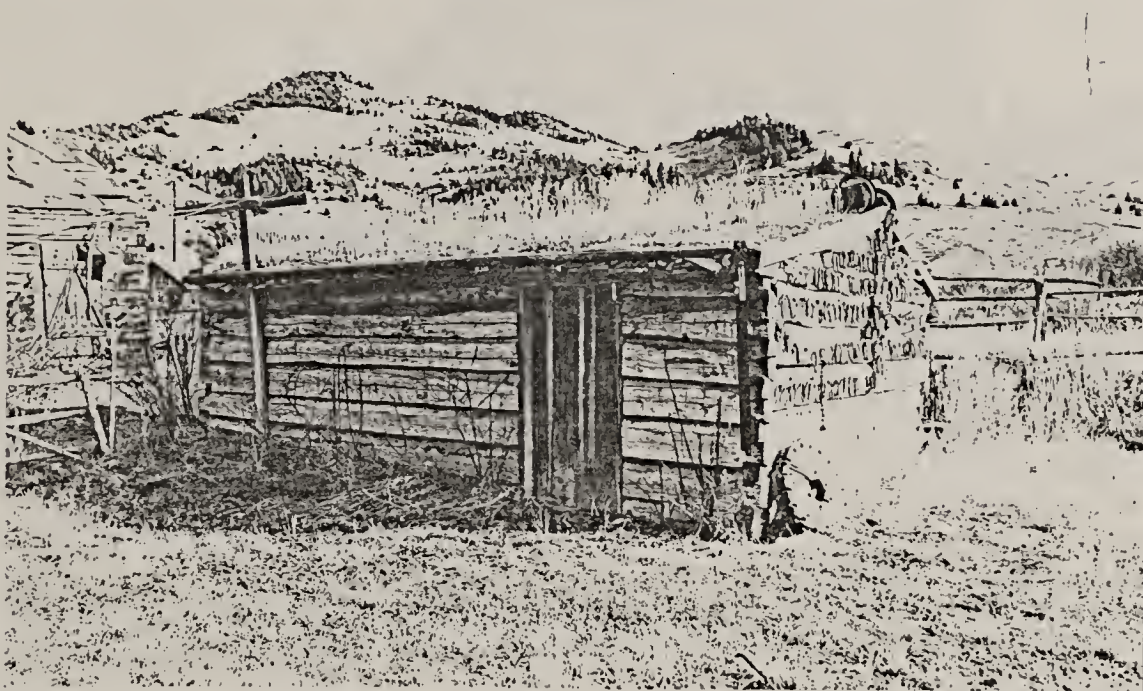
Figure 3-91. Looking southeast at log cabin.

The structure is in fair condition, with some deterioration of sill logs. There is no visible foundation.

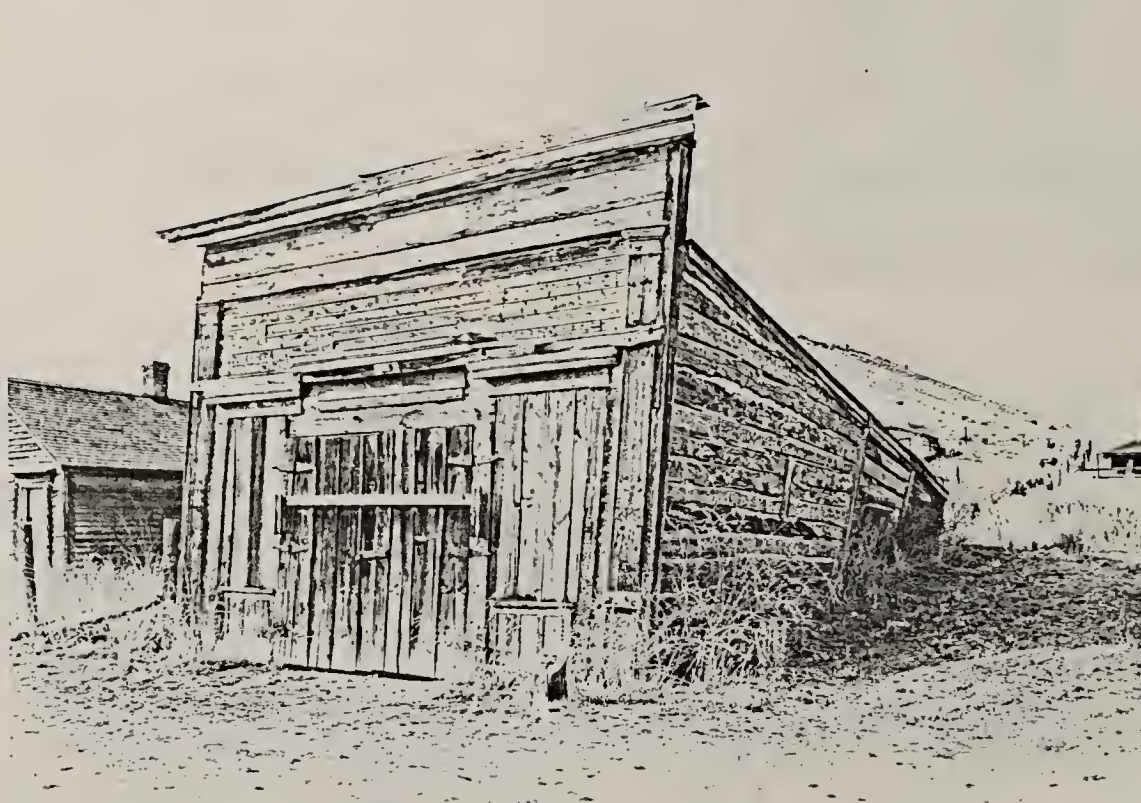
Figure 3-92. Looking northwest at the drugstore structure.

The structure is in poor condition with a deteriorating roof, rotting wall logs, and rotted sill logs. The structure leans to the north and east. There is considerable settlement in the rear of the structure.

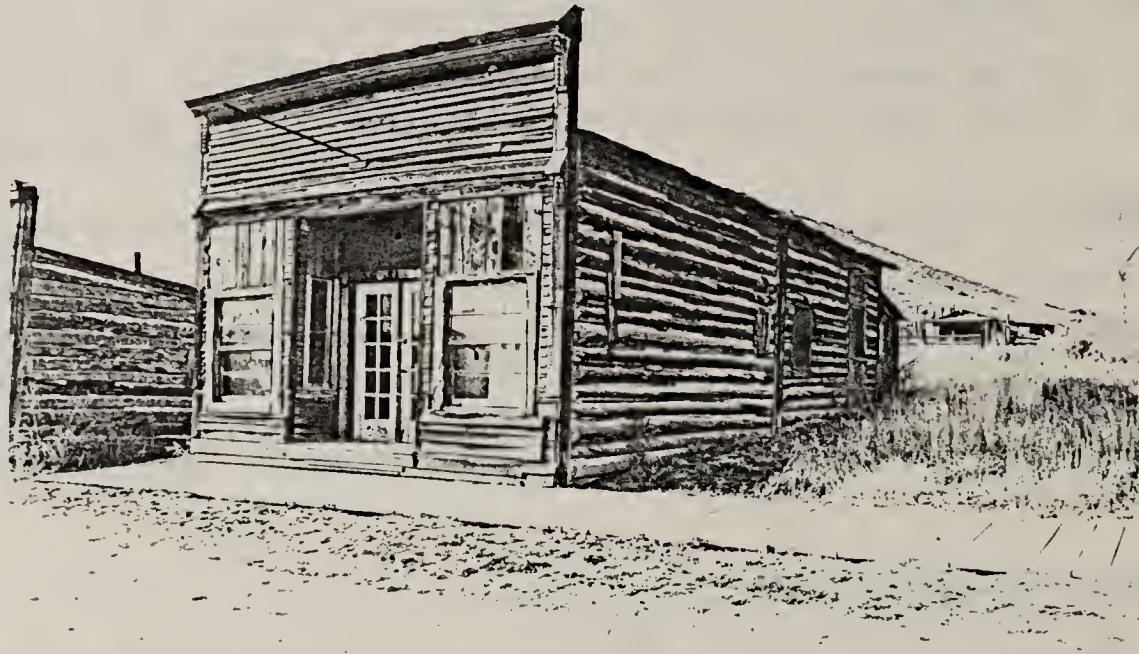
Figure 3-93. Looking northwest.

The gable roof is covered with corrugated metal that is rusting through. There is a wood frame lean-to added to the back, with a board-and-batten roof, two open sides, and a concrete floor.

The interior consists of one room with evidence of additional walls and finish which was added around 1969-1970. The structure is in poor to fair condition, with a deteriorating roof, rotting wall logs, rotten sill logs, and no foundation. The structure is settling in the center, causing some structural damage.

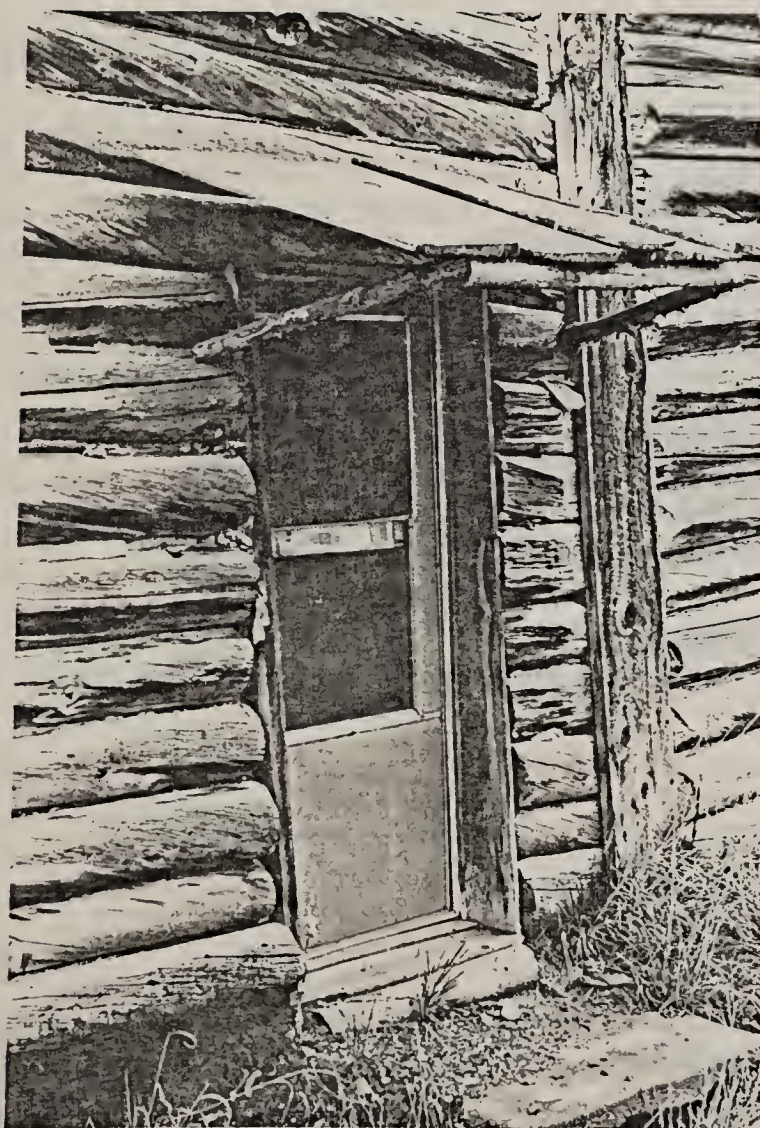
[Trailer door added]

[Settlement of building
at this point]

[Area dug out by rodents,
leaving no support]

Figure 3-94. Looking east at new doorway added to structure.

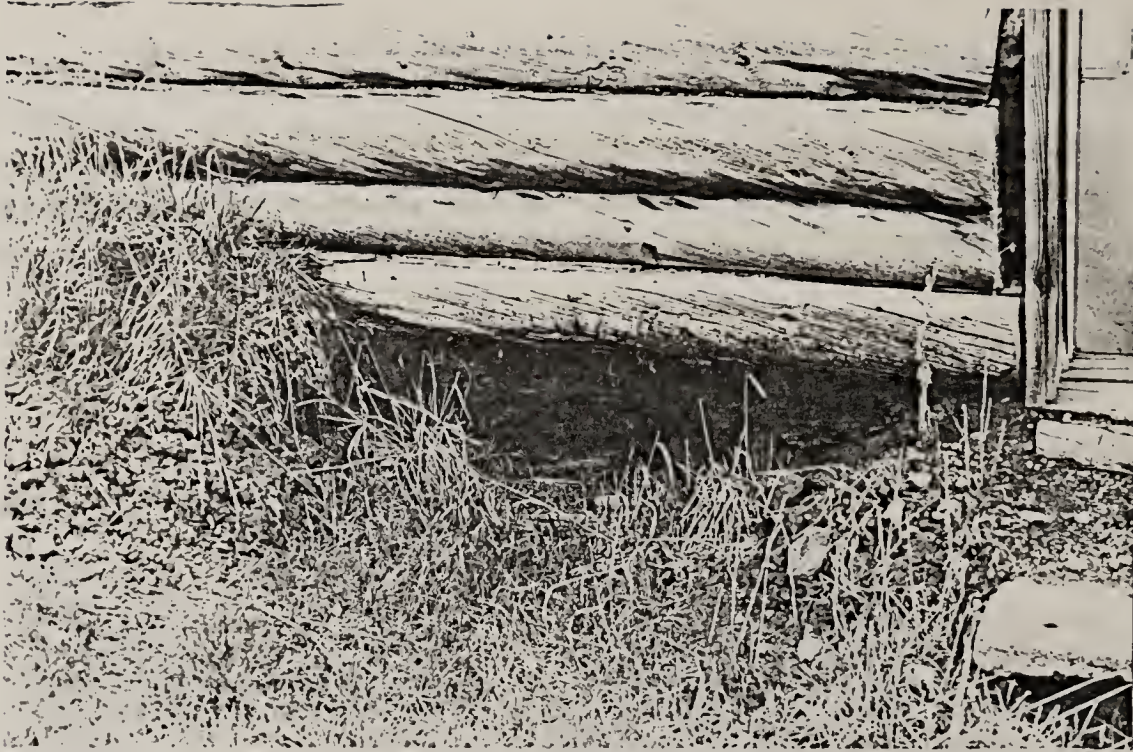
Figure 3-95. Looking east at area dug out by rodents.

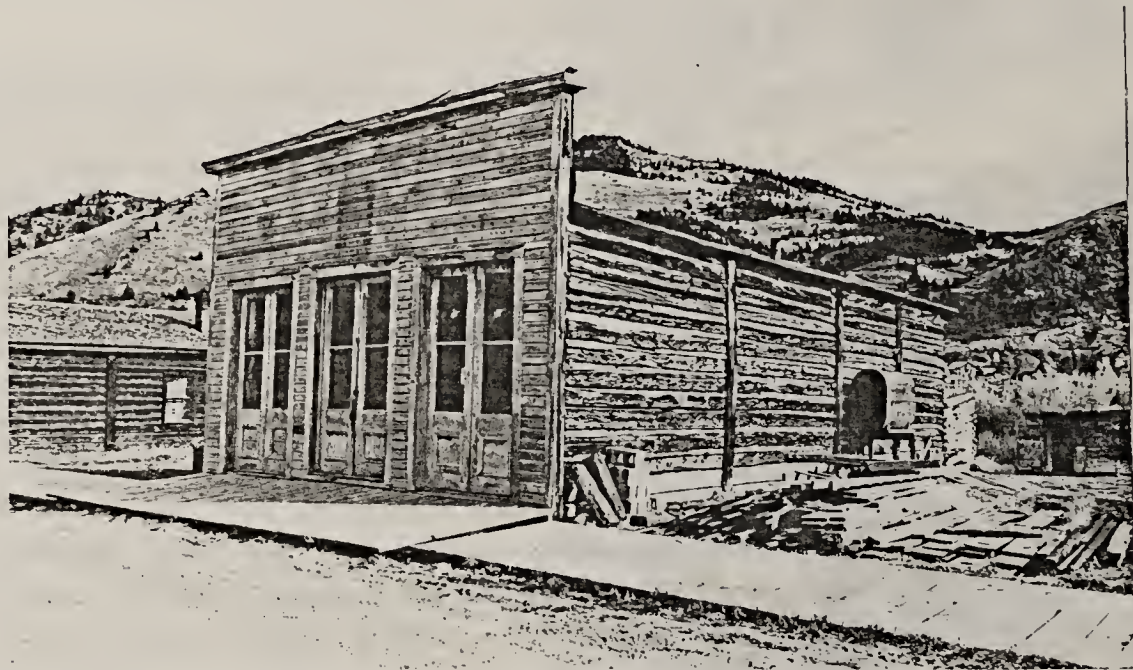
Figure 3-96. Looking southeast at saloon.

The interior of the saloon has a beaded ceiling, wainscoting on side walls, and built-in shelving. A modern office has been built in at the northwest corner. The building is in fair to good condition, with metal patching on both sides of the false front, failure of some details, and deterioration of some logs and siding.

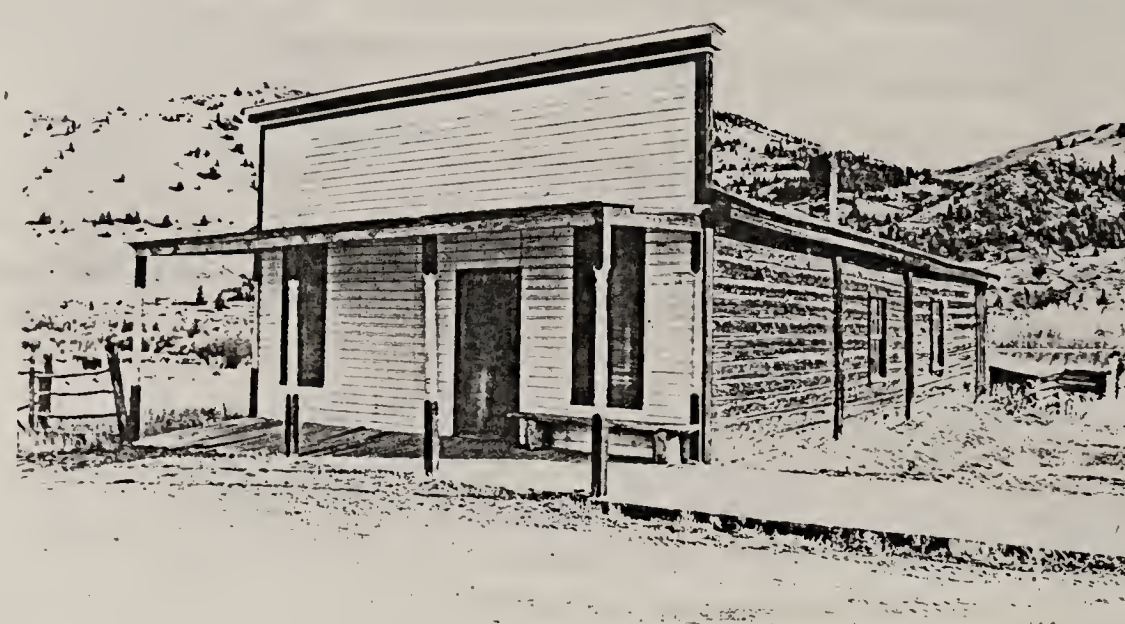
Figure 3-97. Looking southeast at restaurant.

The interior has undergone numerous alterations. It has lowered ceilings and new gypsum board finish. The restaurant is in fair to good condition and rests on an intermittent stone foundation. There is some deterioration of the sill logs.

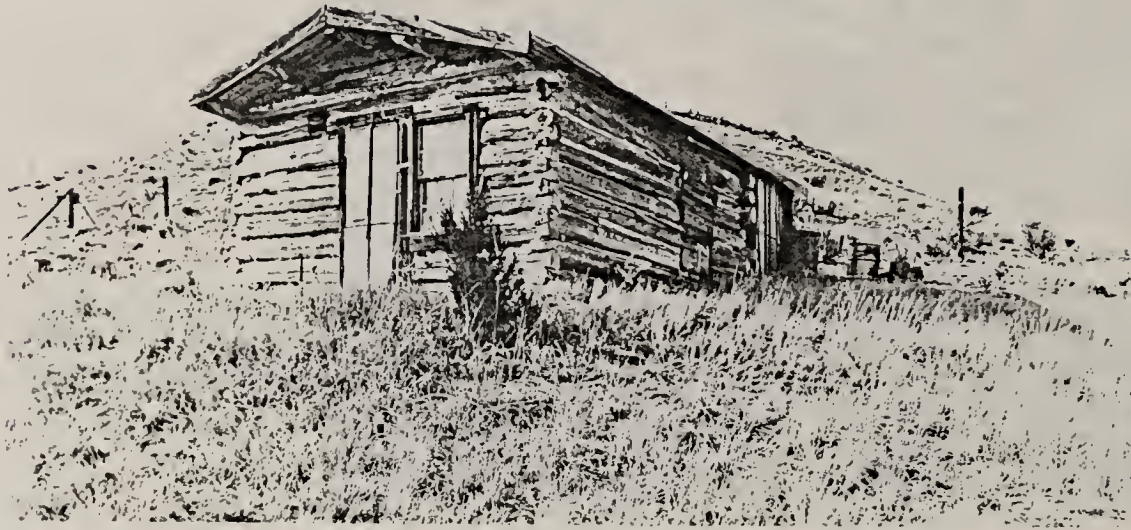
Figure 3-101. Looking northwest at log cabin.

The structure is a one-story hand-hewn cabin with V-notching in the corners, lime and cement mortar daubing, and remnants of white-wash. There is evidence of a sod gable roof that now has asphalt sheeting supported by five log purlins extending out from the front. A frame structure with asphalt roofing and siding was added to the rear. There are six-over-six wood double-hung windows, a wood paneled door, and no visible foundation. The one-room interior is completely wallpapered. The structure is in poor to fair condition, with some rotting of the sill logs, some wall deterioration, and a poor roof.

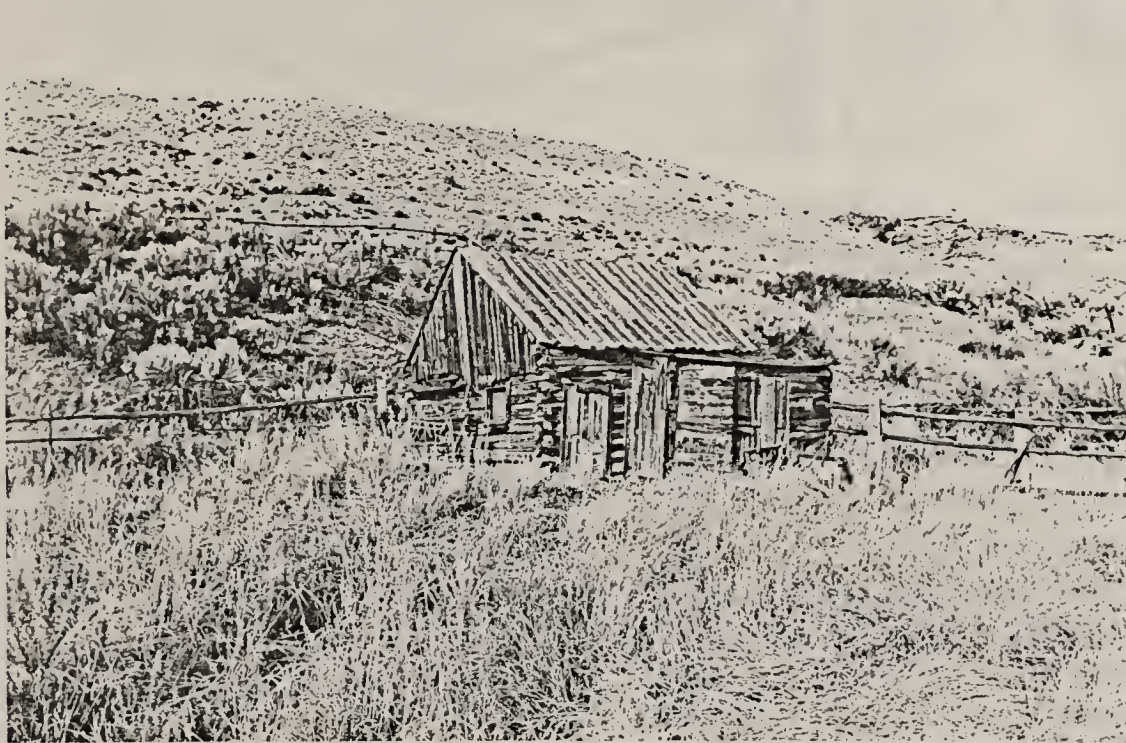
Figure 3-104. Looking northeast at barn.

This structure is a one-story hand-hewn log barn with square corner notching. The windows have been boarded up and there is a wood panel door on the south side. There is no visible foundation except for a few stones. The pitched gable roof has board-and-batten roofing with board-and-batten gable ends. There is a wood frame addition on the south side of the barn, with board siding and an asphalt shed roof. The barn sits in the northeast corner of a three-pole corral. It is in poor to fair condition, with a deteriorating roof, rotting logs, rotten sill logs, and no foundation.

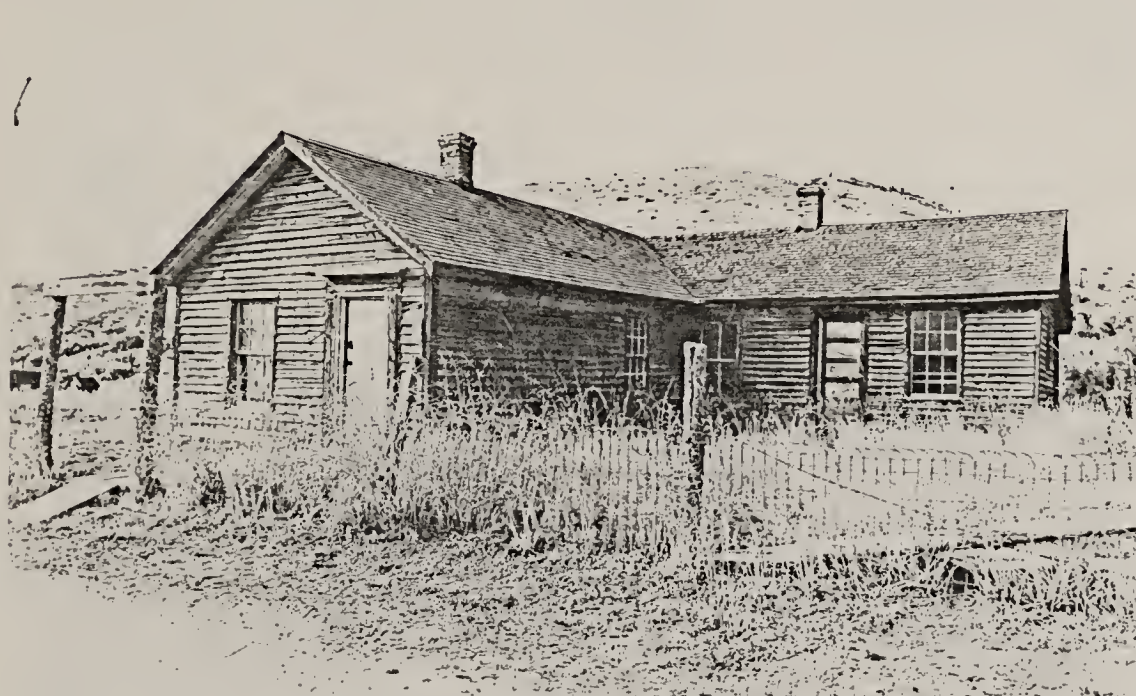
Figure 3-107. Looking northeast at residence.

The interior consists of five rooms, with a crawl space beneath. Previous settlement has caused some heaving in the center of the house. The structure is in fair to good condition, with some curling of the exterior clapboard and some rotted sills and clapboard base.

The structure was acquired by Fish, Wildlife, and Parks in 1969. Stabilization work has been done as follows: 1973--stone foundation repaired at the corners and concrete foundation poured, rotten foundation logs replaced, roof substrate repaired, roof resingled with cedar shingles, and windows and doors repaired.

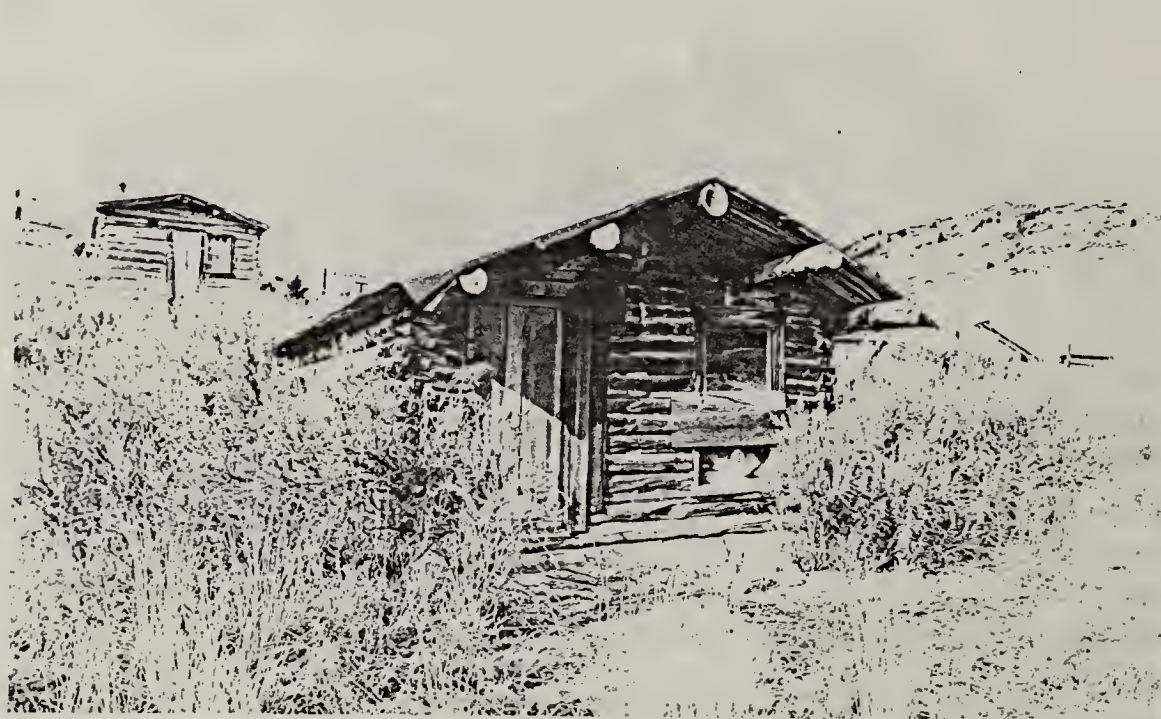
Figure 3-108. Looking northeast at log cabin.

This structure is a one-story log cabin with flat corner notches. There is evidence of some mud daubing with most of the daubing of a cement mixture. The asphalt-sheeted roof is supported by five log purlins which extend out over the front wall. There is a one-over-one wood double-hung window, a vertical paneled door, and no visible foundation. The structure is in poor condition, with a poor roof, deteriorating wall logs, and rotting sill logs.

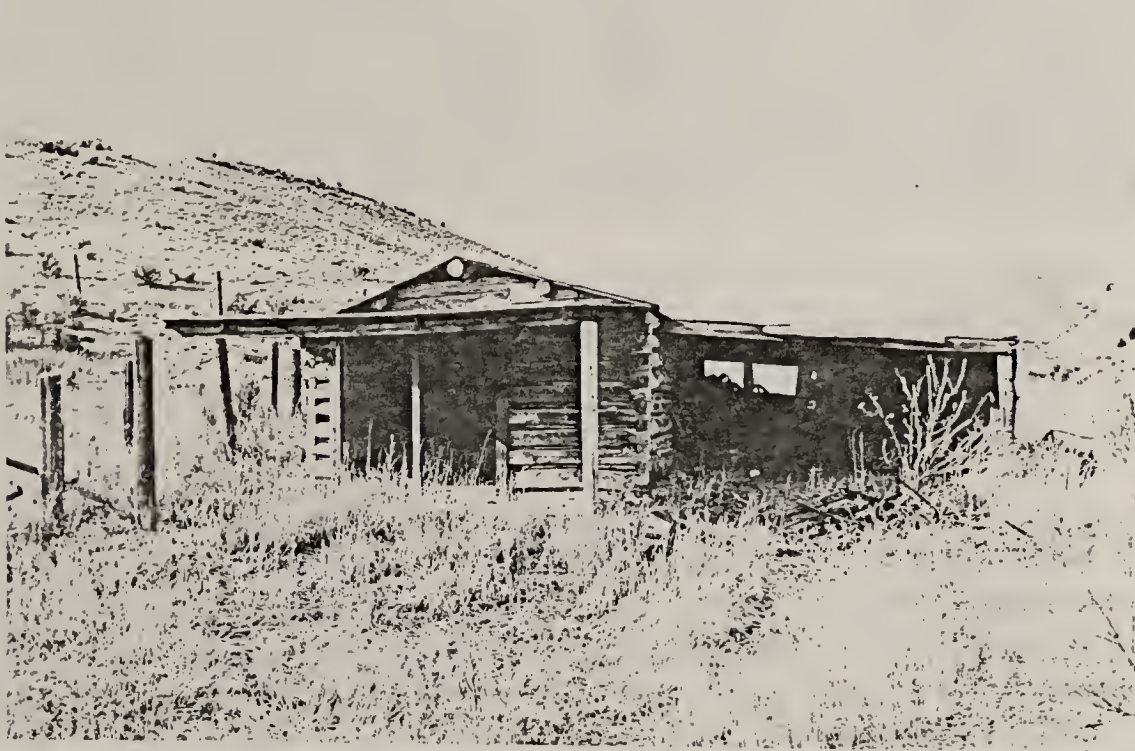
Figure 3-109. Looking north at horse barn.

This structure is a one-story log horse barn with square corner-notching and hand-hewn front and interior walls. An asphalt sheet gable roof is supported by five log purlins with the outer two hand-hewn. There is a wood frame lean-to on the east side with metal siding and roof. Both areas are open to the south. The log structure has a post-and-beam-supported roof extending across the front, a floor of hand-hewn boards, and a manger on the east wall. This structure is in fair condition, with sill log deterioration and deteriorating roof.

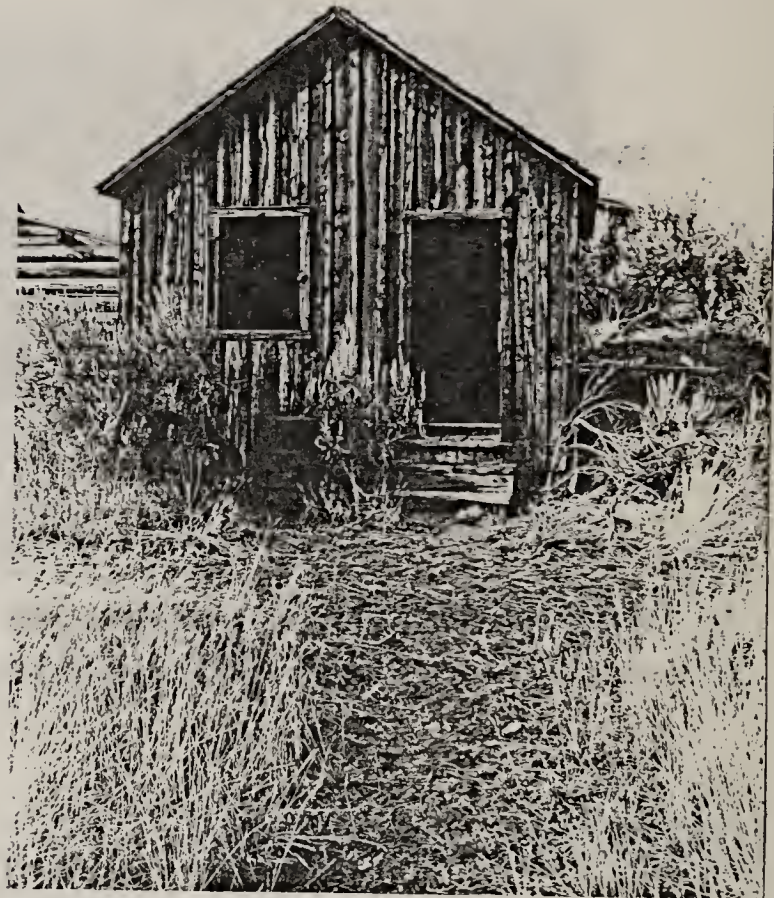
Figure 3-116. Looking north
at frame shed.

This structure is a one-story wood frame shed with board-and-batten siding and a pitched gable roof covered by wood shingles. The structure sits on stone corner piers. The doors and window are missing. The structure is in fair condition, with rotting at the base.

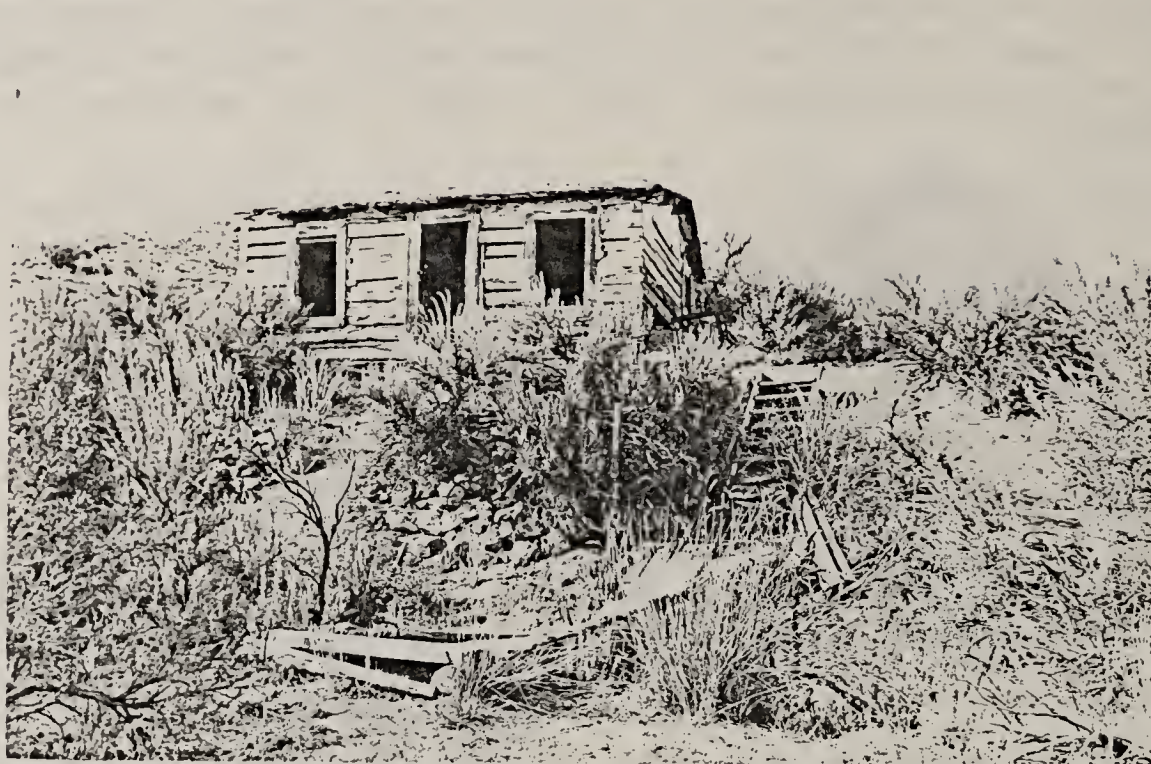
Figure 3-123. Looking north at cabin.

This is a one-story hand-hewn log structure with square corner notching and cement daubing. There is no visible foundation, with the sill logs sitting on grade. The gable roof is supported by five hand-hewn log purlins and has sod over a board-and-batten surface. Corrugated metal has been placed over the sod and has deteriorated. The windows were wood double-hung, but the sash and glass are missing. There is a wood paneled door. The interior is log and there are vertical board partitions.

The structure is built into the hillside overlooking the Mill Ditch and has a root cellar on the back of the northwest corner that extends into the hillside. There are wood steps down to a wood foot bridge over the ditch. The structure is in poor to fair condition, with rotting sill logs and wall logs on the north end. The windows are missing and the roof has deteriorated.

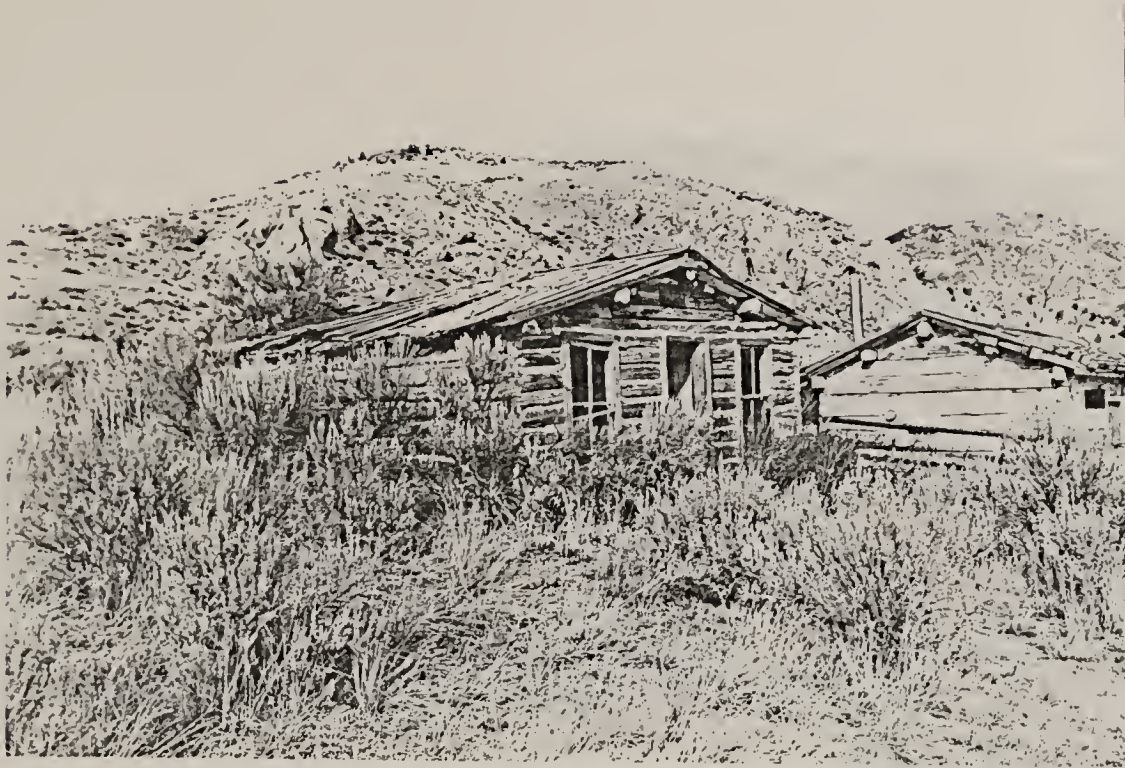
Figure 3-124. Looking northeast at cabin.

This structure is a one-story log cabin with a front facade of hand-hewn logs, with V-shaped saddle notching. There is some cement daubing in the log walls and some evidence of mud daubing. There is no visible foundation, with the sill log sitting on grade. The gable roof is supported by five log purlins. There is evidence of an original sod roof over board and battens. The sod has been replaced by metal sheet roofing that remains in some places. The windows are two-over-two double-hung wood sash, with missing glass. The door is wood paneled. There is a log extension on the back of the structure and a wood frame structure added beyond that.

The interior consists of six rooms in the main structure, with a root cellar in the northwest corner accessible from the kitchen. The logs have been hand-hewn on the interior, with wood chinking hand-hewn between them. Wallpaper and fiberboard were added later as a finish material. The structure is in poor condition, with rotting logs, deteriorating roof, no glass in the windows, and heaving of the floor in the center of the structure, suggesting settlement of the outer walls.

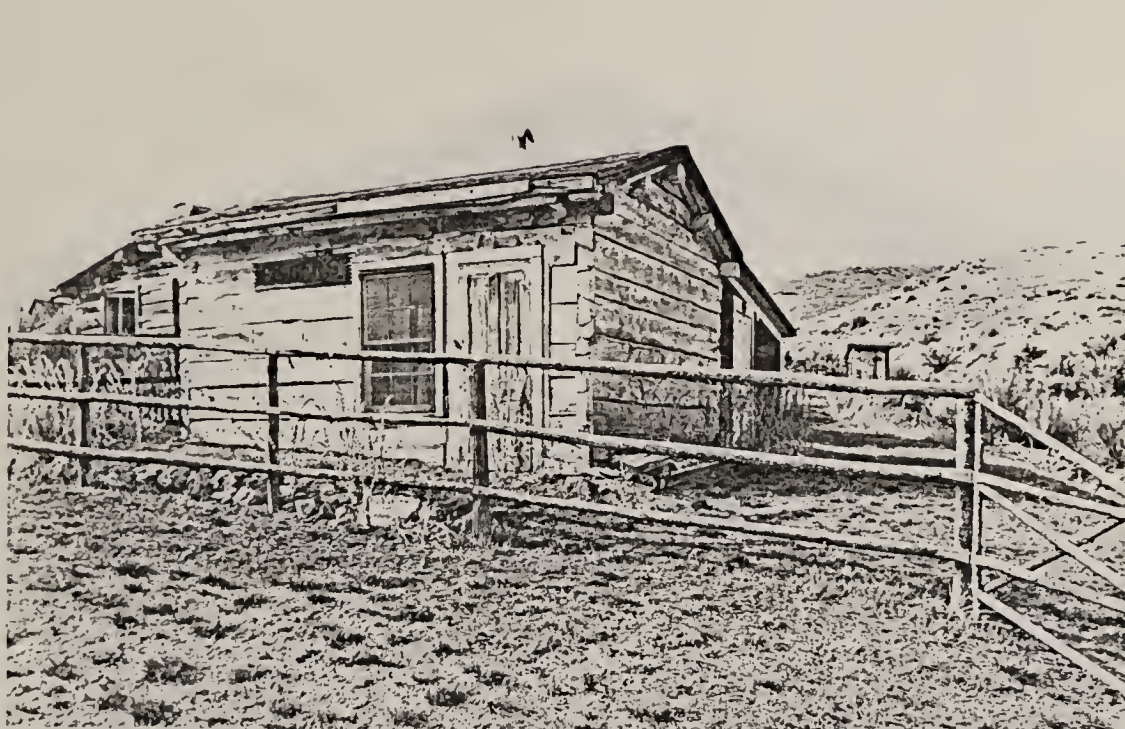
Figure 3-126. Looking northwest at cabin.

This structure is a one-story hand-hewn log cabin with a double-dovetail notch at the corners. There is evidence of some lime and mud daubing and some cement daubing. The logs have been whitewashed at one time, but it has mostly weathered away. The structure sits on a stone pier foundation. The gable roof is supported by five hand-hewn log purlins, is covered by sheet composition roofing, and has a metal stovepipe. There are six-over-six wood double-hung windows and a wood paneled door. Electricity was wired into the structure in the early 1970's. The structure is in fair to good condition, with some rotting of the sill logs, very little daubing in the walls, and some deterioration of the roof. The interior was not surveyed.

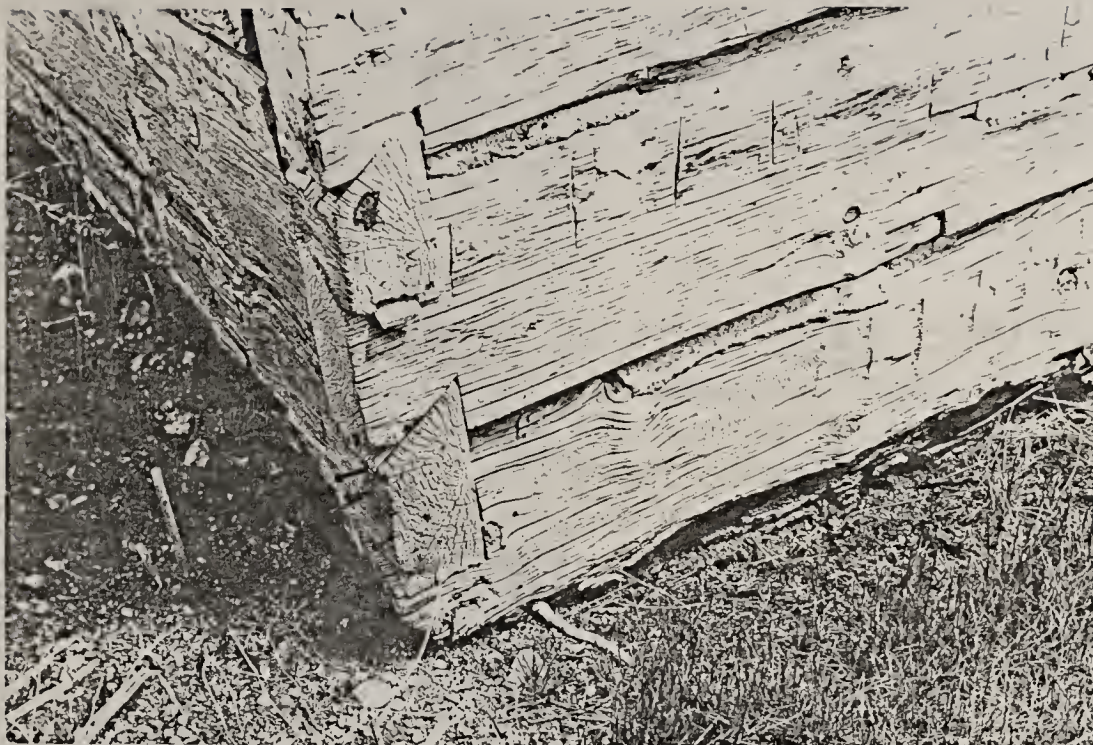
[Sill logs rotting
because it is
sitting on the grade]

Figure 3-129. Looking northeast at the base logs.

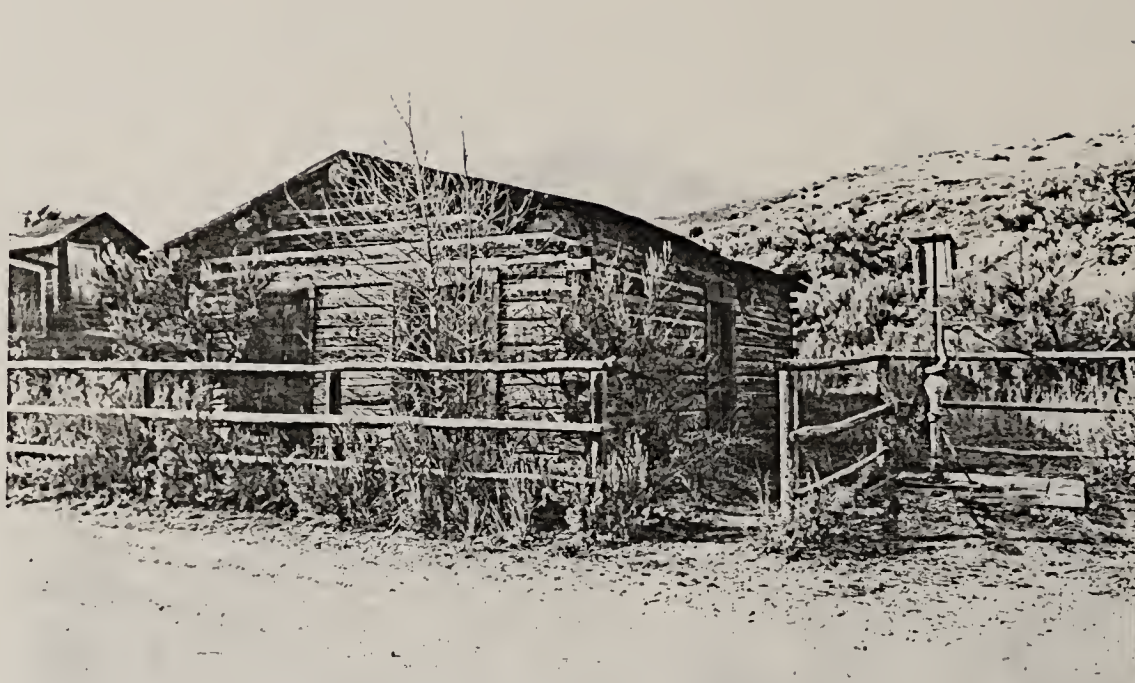
Figure 3-130. Looking northwest at cabin.

This structure is a one-story hand-hewn log cabin with an interlocking square notch and extended ends. The ends of the notches are painted pink. The logs extend up into the gable ends, with cement mortar daubing and some mud daubing showing through missing areas. The structure sits on random stone piers. The gable roof is supported by five log purlins, with the outer purlins hand-hewn. The board roof is covered by sheet composition roofing. The double-hung wood windows are covered with boards. There is a wood paneled door on the east side.

The interior consists of two rooms with plywood covering the walls and ceiling. The interior wall has three hand-hewn logs at the top which carry the purlins and extend through the walls on the sides. This work was put in around 1970, when a side shed was removed. The structure is in good condition, with some rotting of sill logs and daubing missing from the walls.

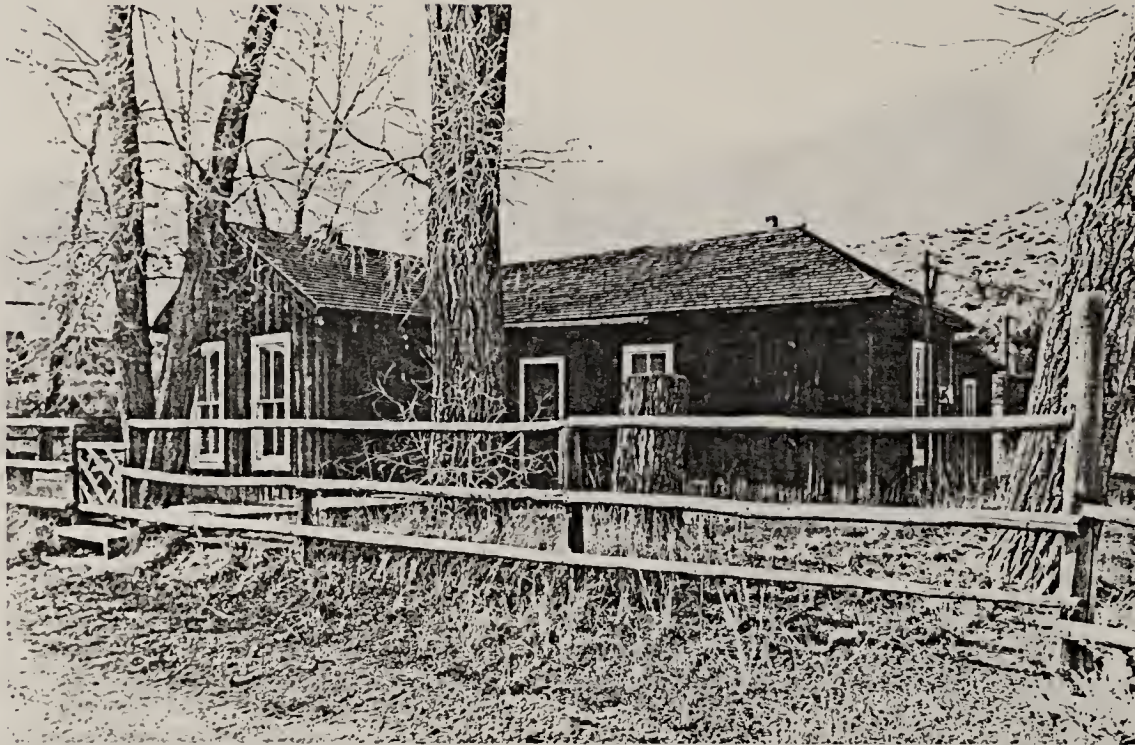
Figure 3-132. Looking northwest at residence.

This structure is a one-story wood frame residence with board-and-batten siding extending into the gable end and a concrete foundation. The structure has a pitched gable roof on the west with an intersecting hip roof to the east. Wood shingles cover the roof, and there is a metal ridge cap. The chimneys are concrete block. There are two-over-two double-hung wood windows and wood paneled doors. A frame lean-to with board-and-batten siding has been added to the rear of the structure.

The interior has been extensively altered and modernized over the years. In the 1960s, two cement block chimneys were added, a utility shed was removed from the south side, and a bedroom added. A bathroom, pumphouse, and wood shed have been added on the north side. The structure is in good condition, with some staining of the bottom of the board and batten siding because of water coming off the roof.

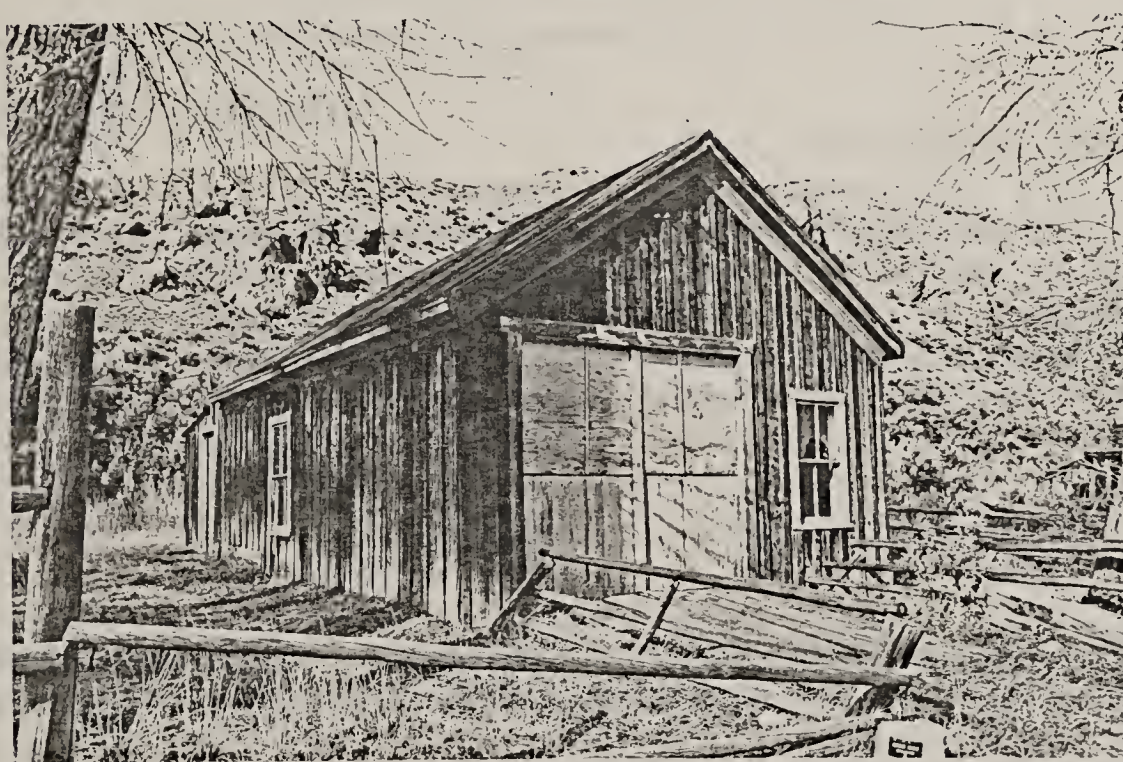
paneled door. The exterior is in good condition, with minor staining at the base of the board and batten siding. The interior is in poor condition. The interior walls have been cut out with a chainsaw. The garage originally was constructed as a residence and later remodeled.

Figure 3-133. Looking northeast at the garage.
